Chena River Lakes Project  
Fairbanks, Alaska

*Overview of Tanana River monitoring and  
research studies near Fairbanks, Alaska*

OVERVIEW OF TANANA RIVER MONITORING AND  
RESEARCH STUDIES NEAR FAIRBANKS, ALASKA  
(with Appendices)

Prepared by  
U.S. Army Cold Regions Research and Engineering Laboratory  
Hanover, New Hampshire

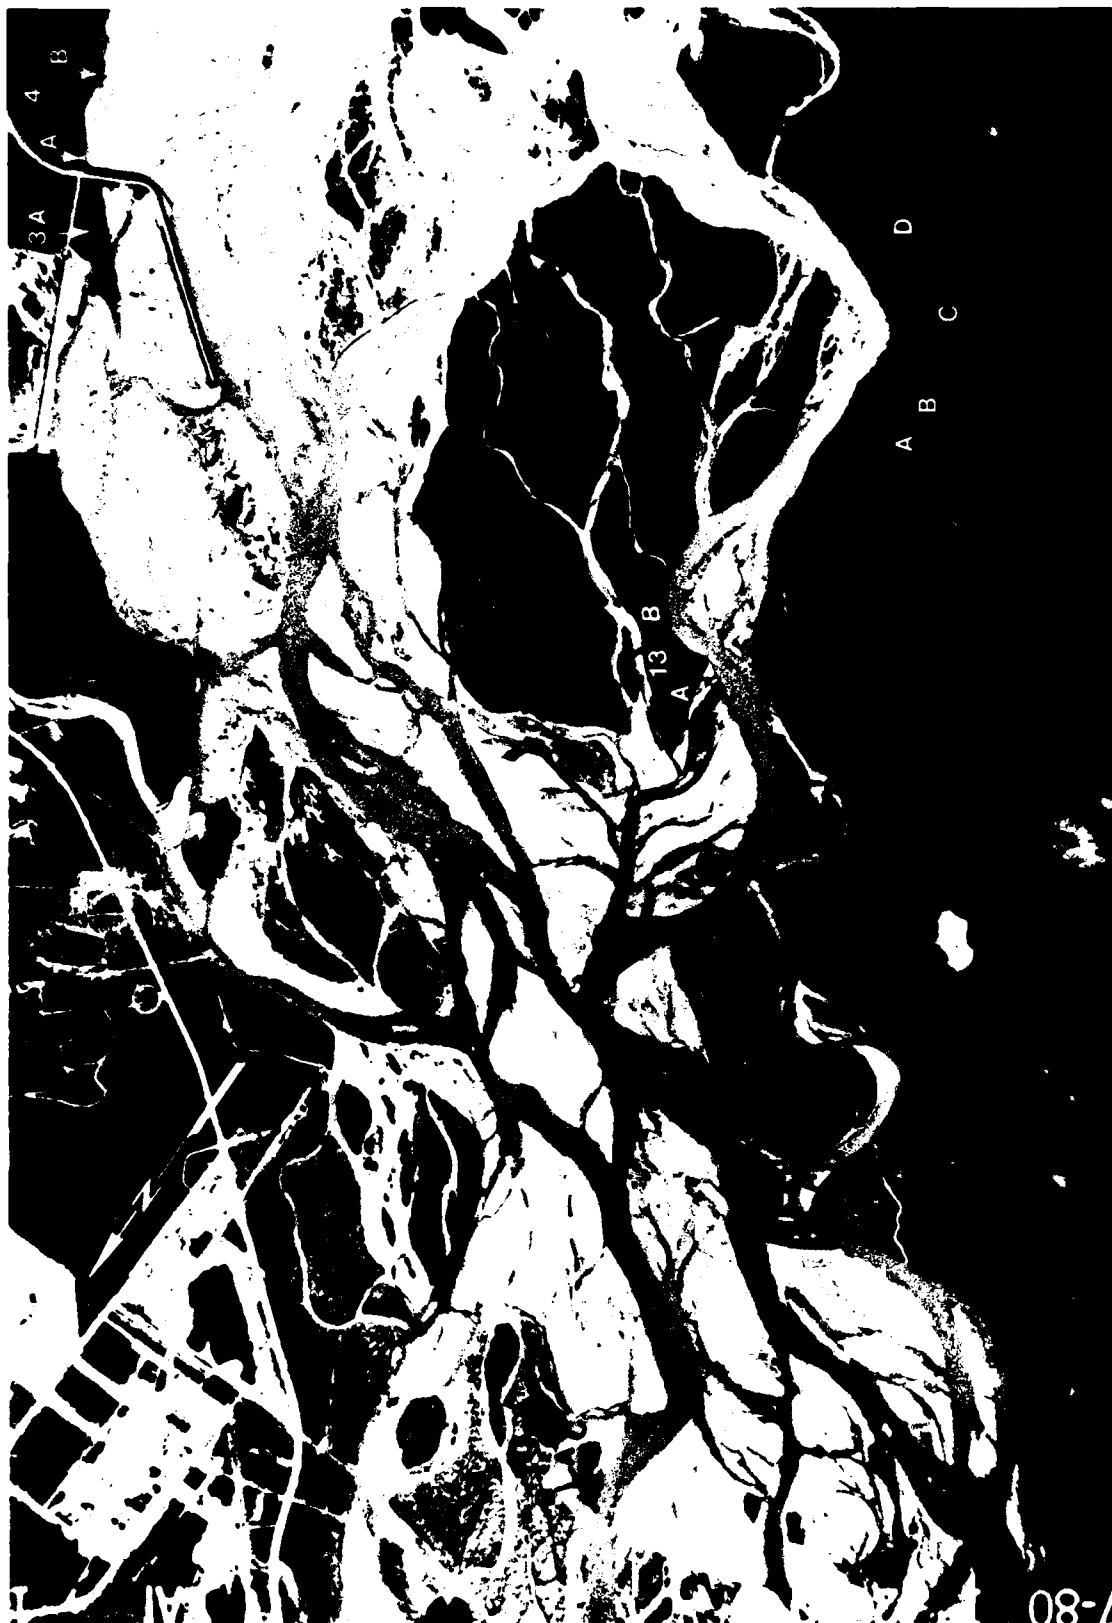
Figure 18. Measuring line locations near the floodway sill groin (mapping base 18-18, Fig. 1).

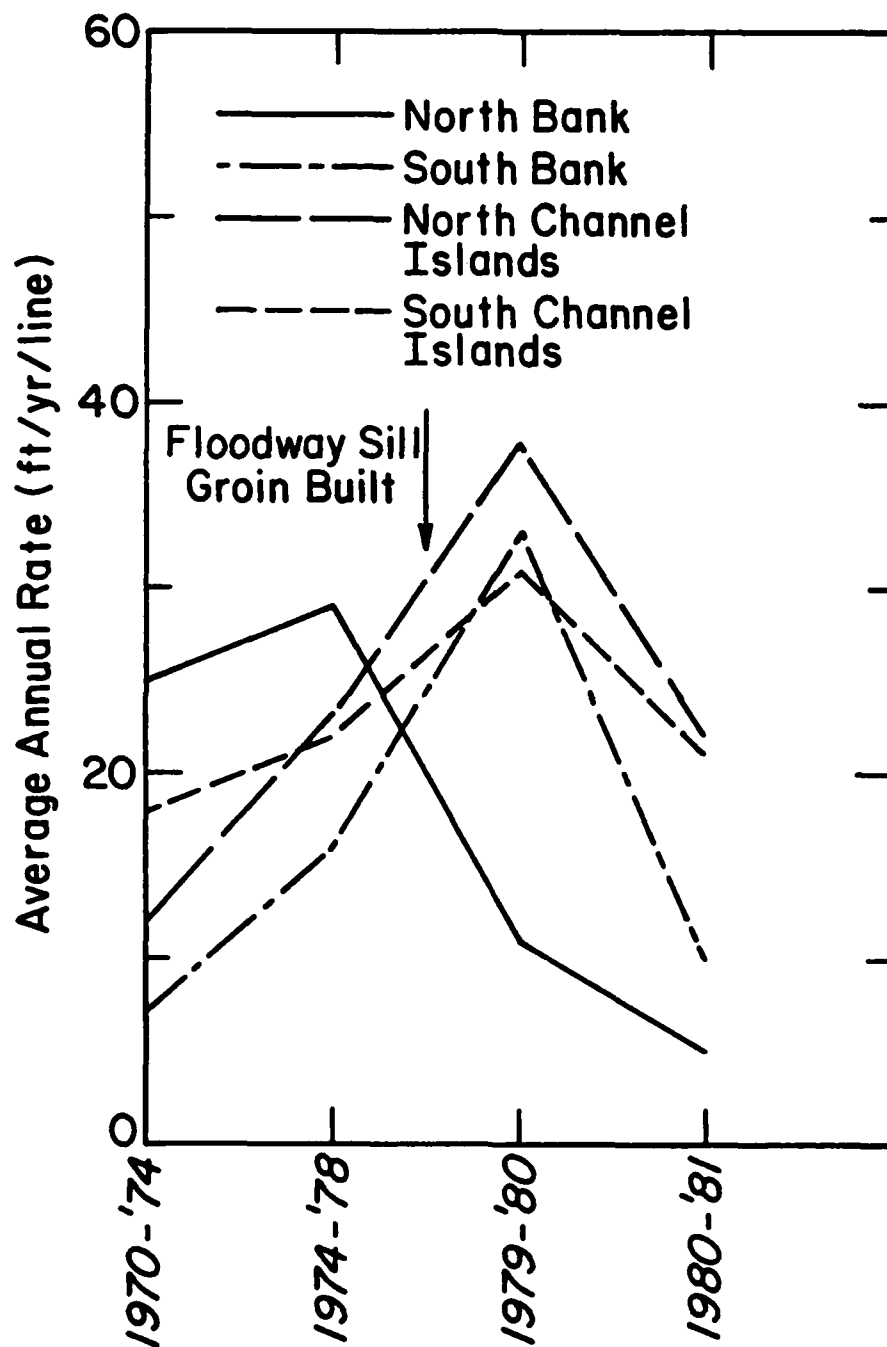
Figure 19. Average linear recession rate per measuring line in the floodway sill groin area.

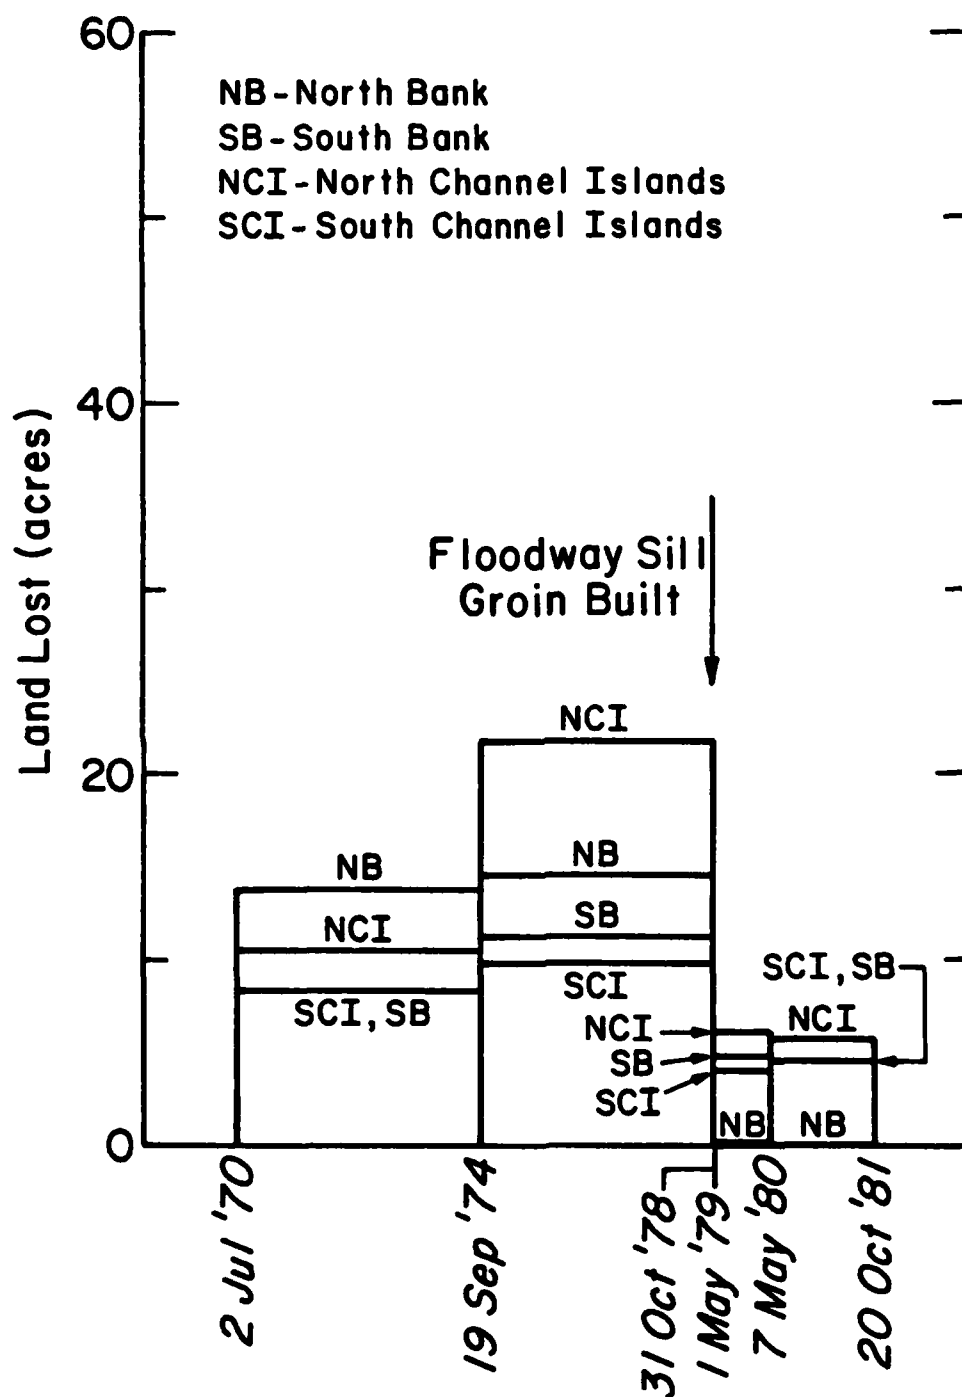
Figure 20. Land lost in the floodway sill groin area.

The amounts and rates of land eroded was also greatest along the north bank (Figs. 20 and 21; Table 7) followed by that along the north and south channel islands and the south bank.

The amounts of the land lost during this interval decreased because the interval was shorter than previous intervals (Fig. 20). Virtually no north bank land was eroded (Table 7). North and south channel banks and the south bank were eroded the most and the rates of land lost increased (Fig. 21) as did the rates of linear recession.

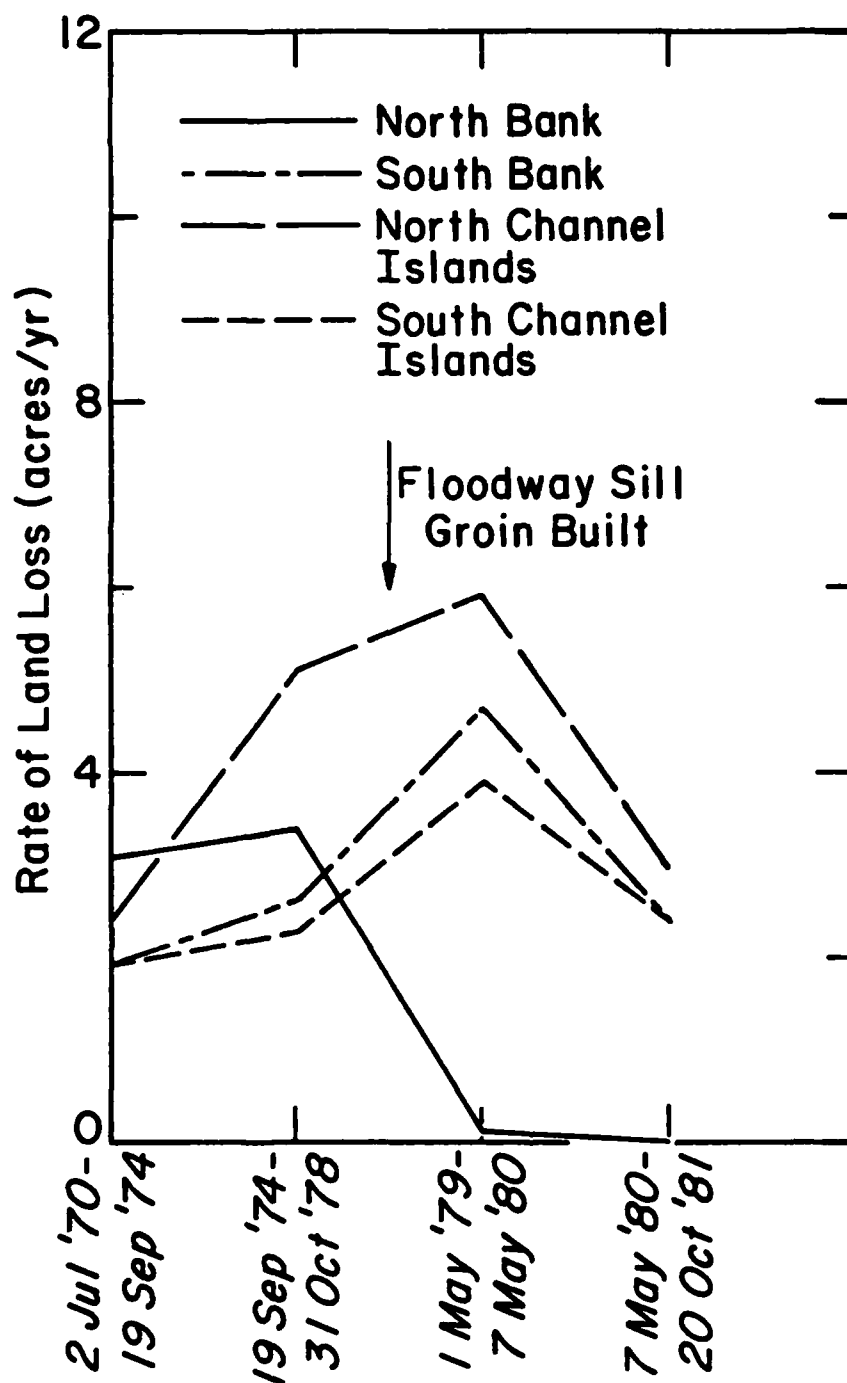
Figure 21. Rate of land lost in the floodway sill groin area.

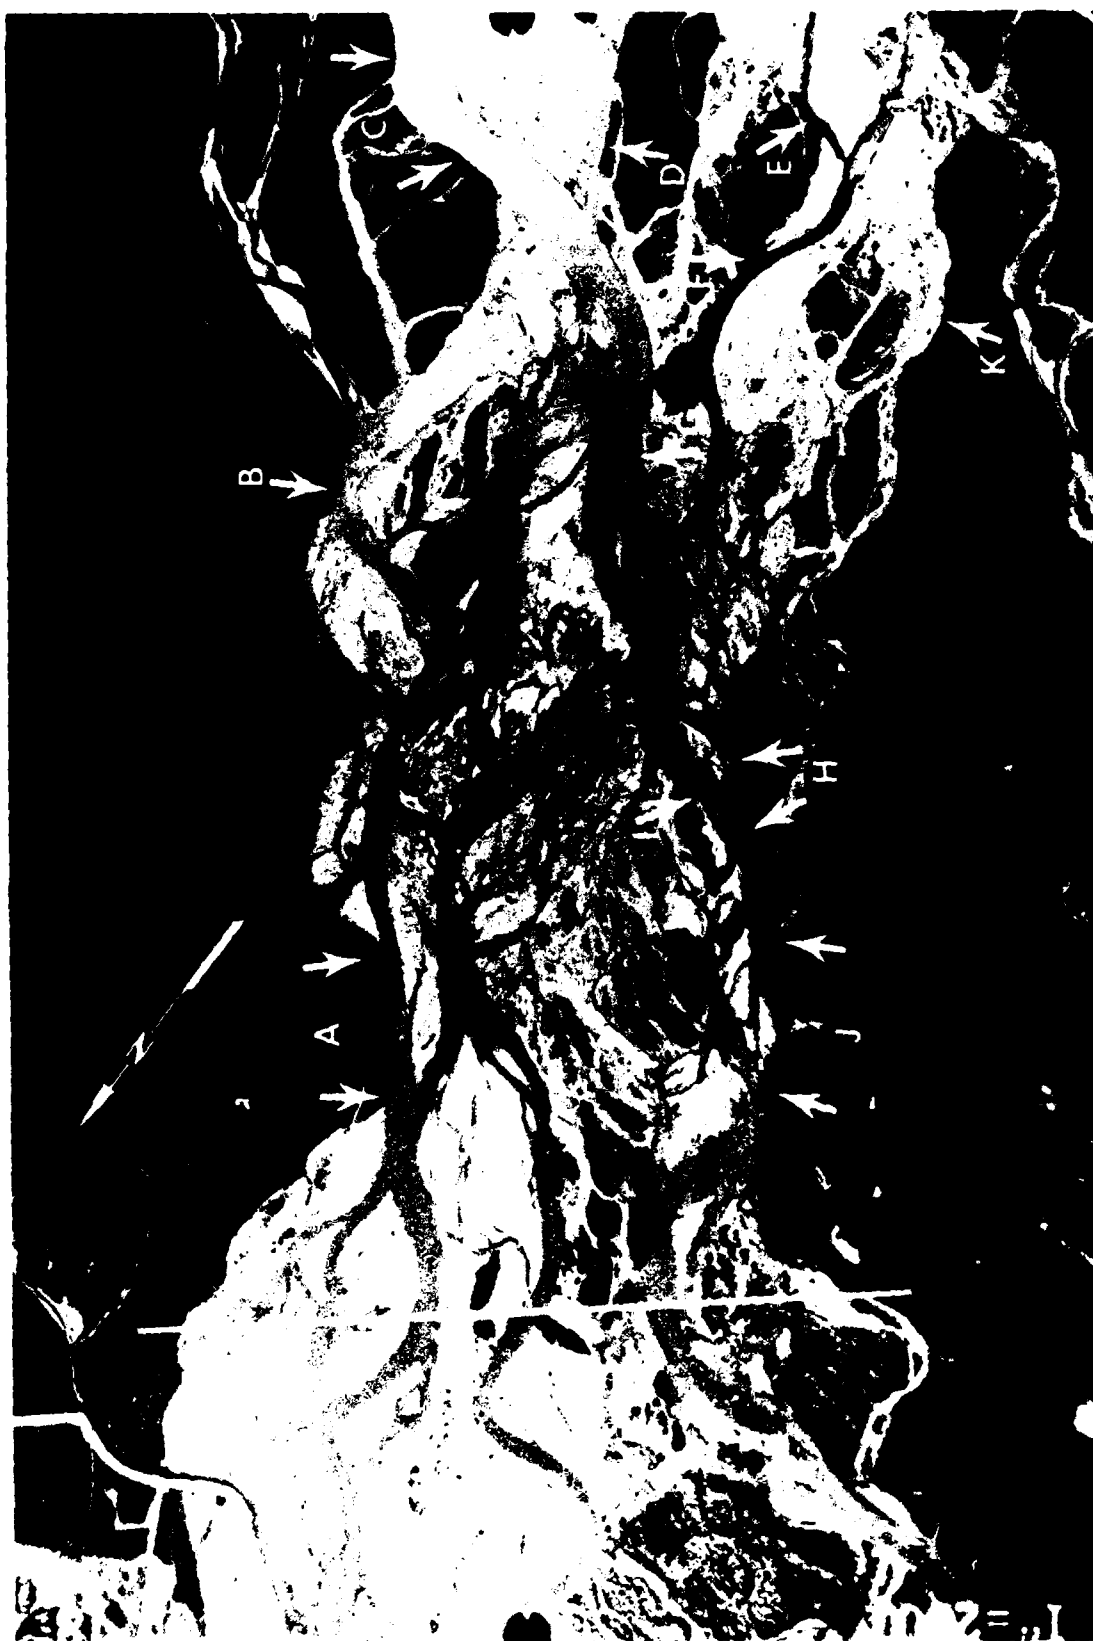
Figure 22. Area 18-16, upstream of the floodway sill groin.

By September 1980 (Fig. 28), there is not much change in the channels south of the groin and the river continued to flow along the north bank downstream of the groin. This north channel was diverted southerly only for a short distance. From 1979 to 1980, mid-channel islands and the south bank appears stable in the 18-16 area (Fig. 22), although the bank at C continued to recede.

Bank recession occurred along six of 17 measuring lines along the north channel and along eight of 16 lines along the south channel (Table 6). Recession varied from 40 to 210 ft along the north channel, 40 to 110 ft along the southern. The average linear recession rates decreased along all the banks (Fig. 19). The amount of land eroded did not change substantially but the rates decreased (Figs. 20 and 21). Areas C, E, F and J in the 18-16 area (Fig. 22) continued to recede from 1980 to 1981. There was no detectable change elsewhere.

Minor recession continued north of 1A and northeast of 1C, at 7A,B, 9B, 11A,B and 13B (Fig. 18). There is little detectable change from 1980 to 1982 (Fig. 31). Minor recession occurred at A, C, H and J (Fig. 22).

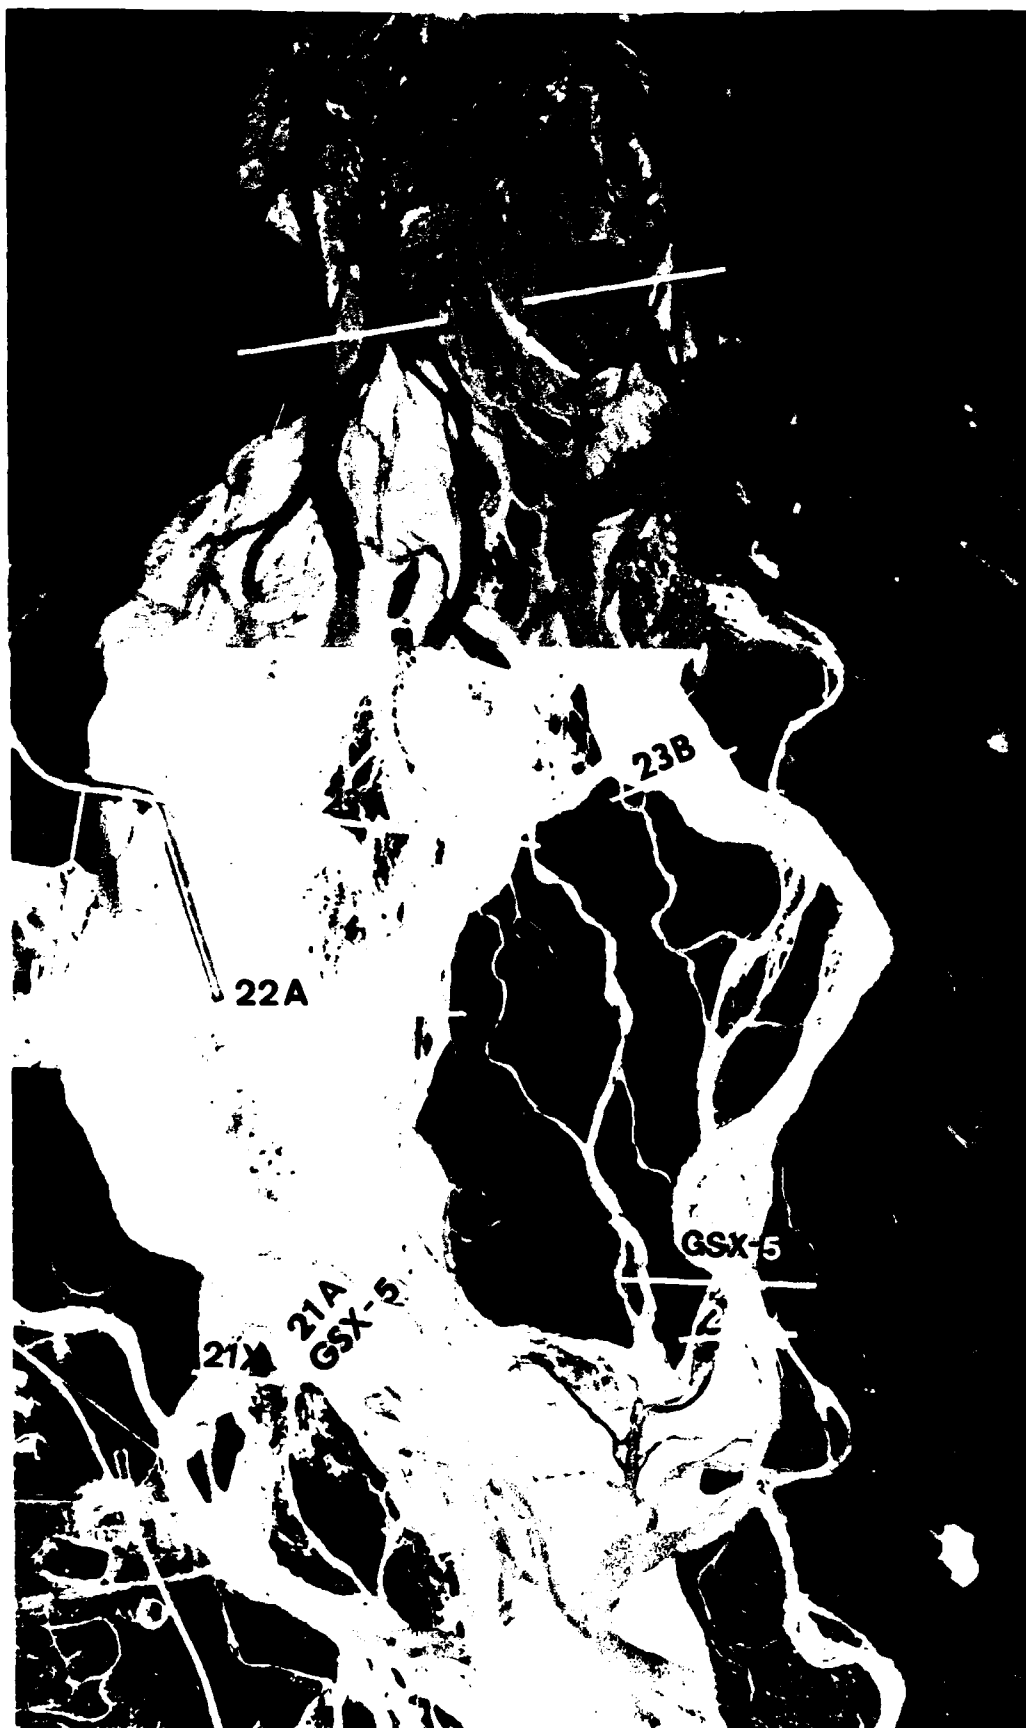
Figure 23. Cross-section locations in the floodway sill groin area.

Pre-construction cross-sections near the the sill groin were taken once at locations 21X,A and C, 22A, 23A,B (Figs. 23 and 24) and several times at the GSX-5 and GSX-6 locations. The GSX-5 and -6 data were not available in time for this report but will be incorporated at a later date. Because available cross-sections were taken only once, channel changes prior to construction of the sill groin could not be measured.

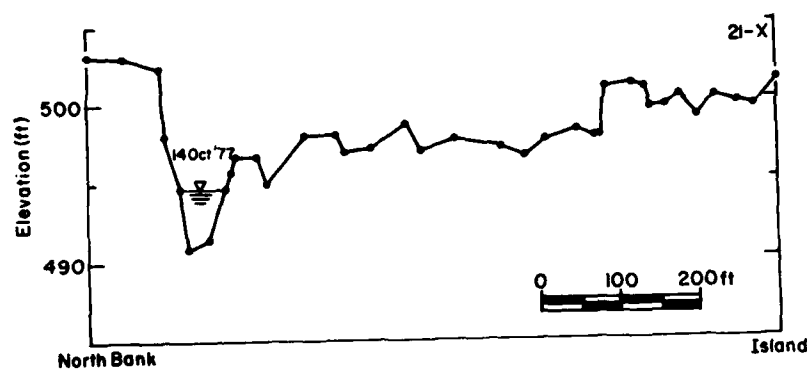
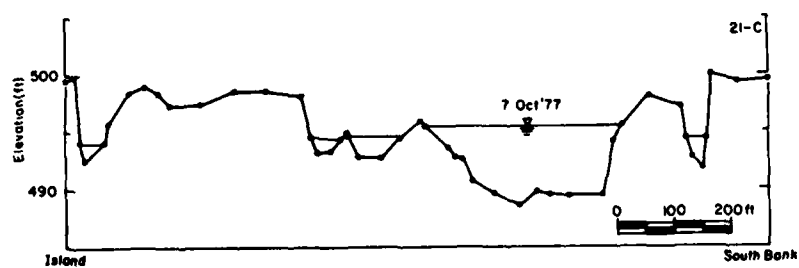
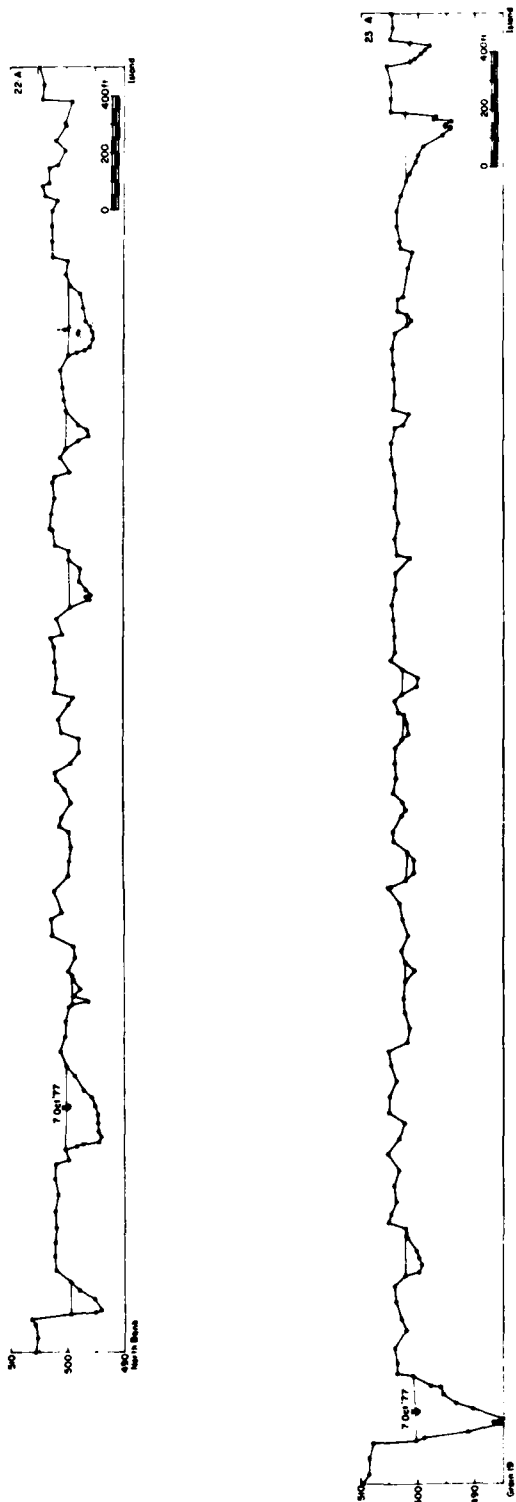
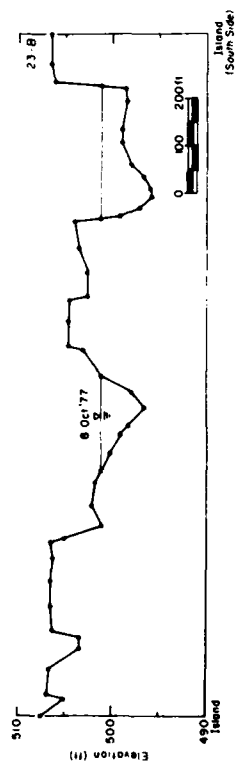
Figure 24. Cross-sections taken in 1977 and 1978 before construction of the floodway sill groin.

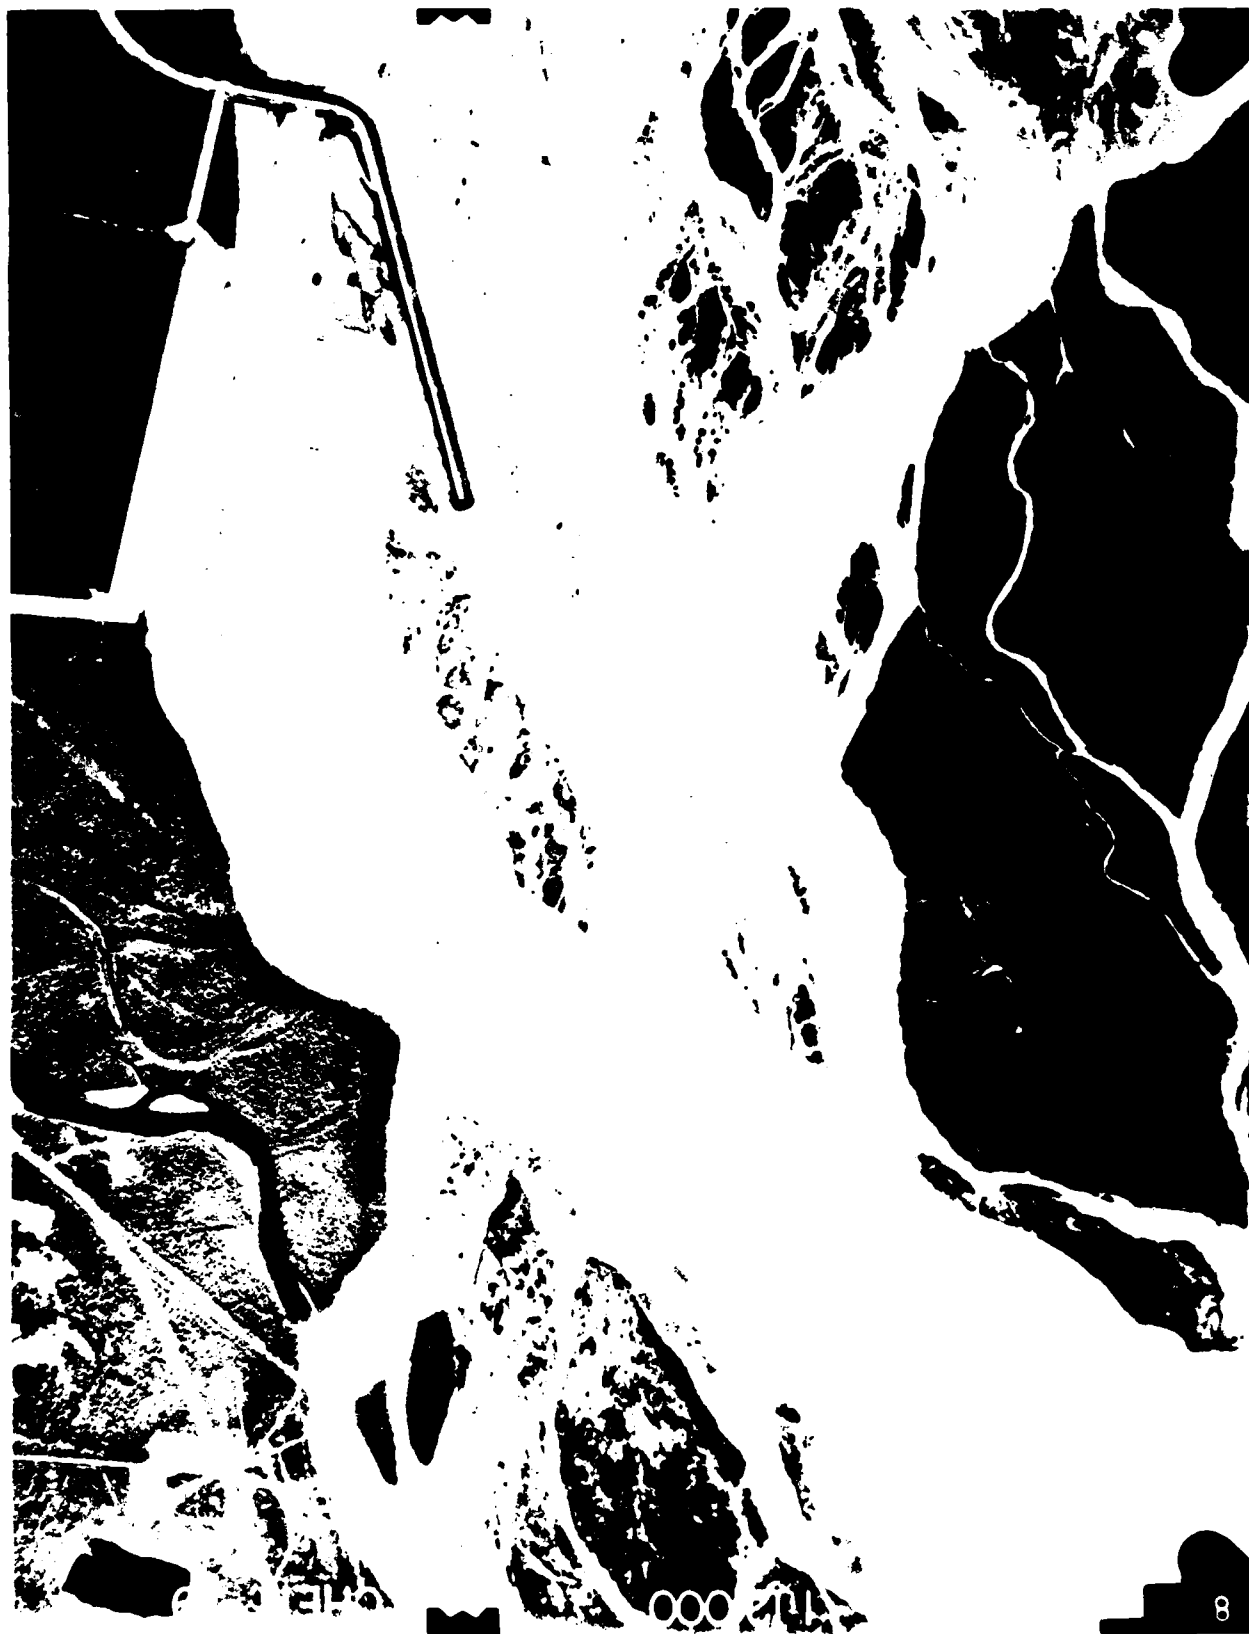
Figure 27. Floodway sill groin, 29 July 1979.

In 1978, before the floodway sill groin was built, a large channel was flowing along the north bank (Fig. 25). When the groin was built (Fig. 26) during the 1978-79 winter this channel was diverted away from the north bank (Fig. 27). The groin reduced the active channel which was 6200 ft wide by 1800 ft. The width of the post-construction channel, 4400 ft, was 29% smaller than the pre-construction width. This is less of a disturbance to the river than that caused by the North Pole groin but there are measurable changes that occurred after construction of this sill groin. The increased southern erosion may be attributable to the groin diverting water to the south and causing more flow through the southern part of the channel.

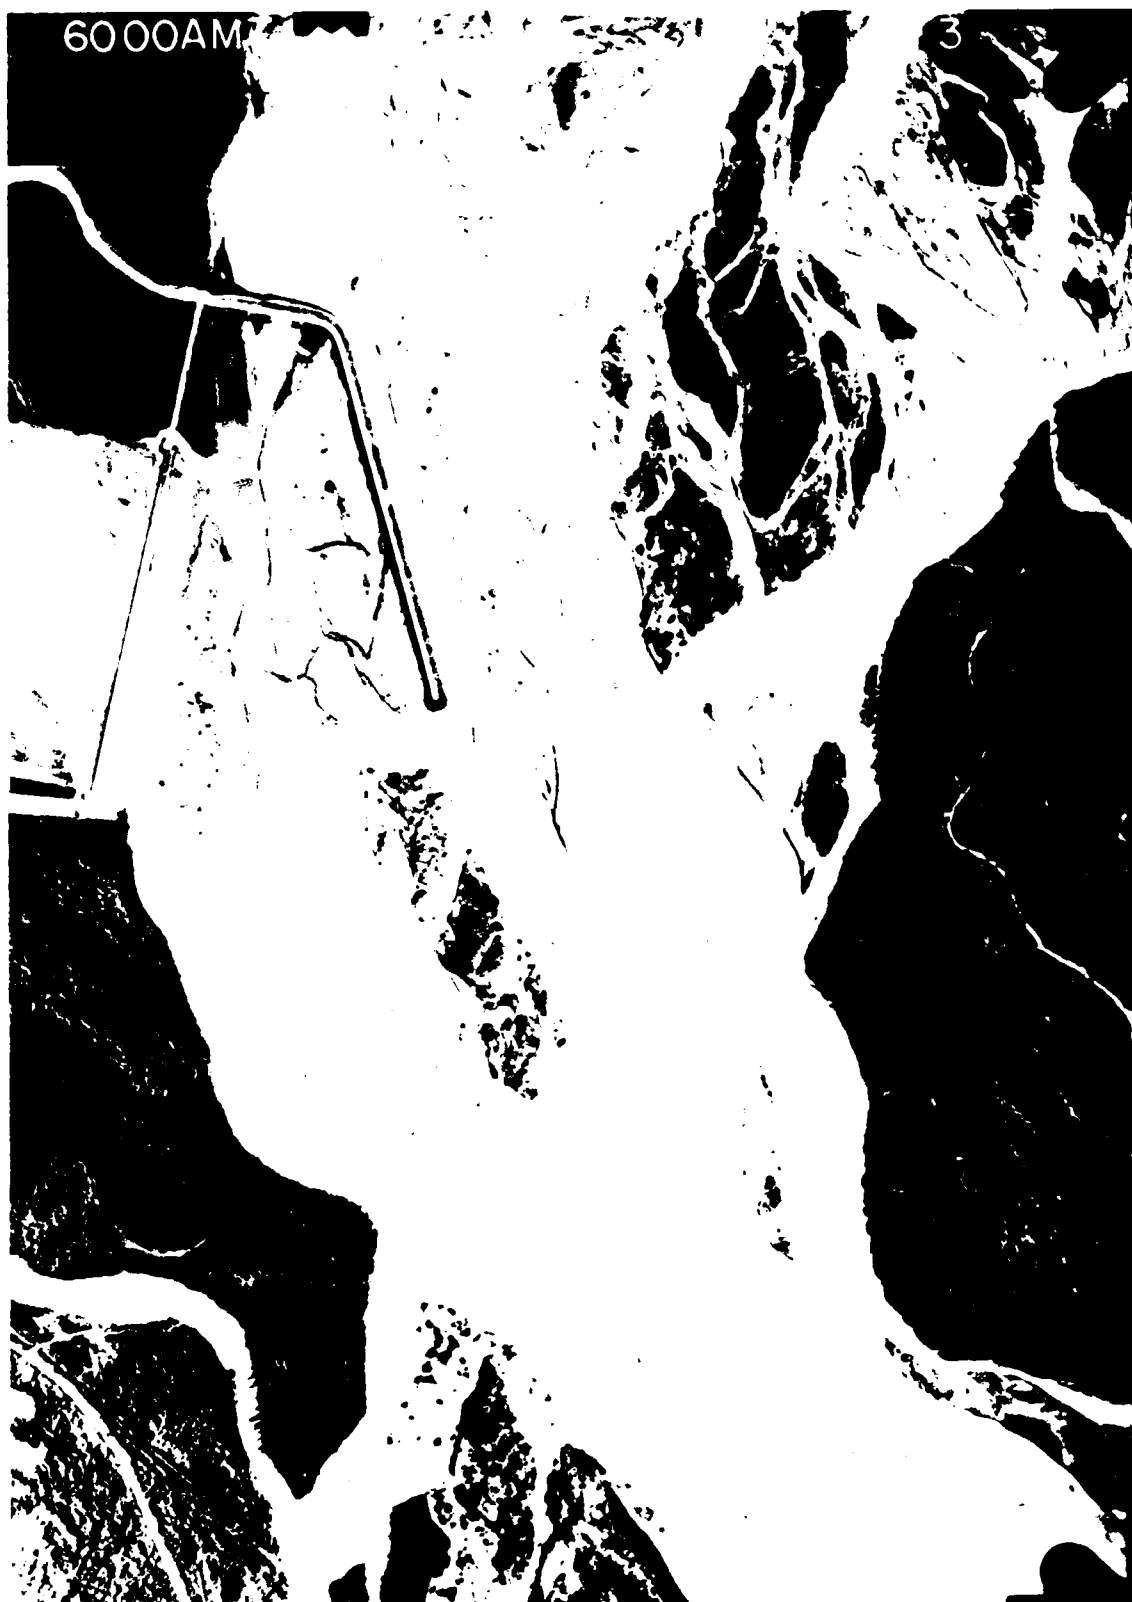
Figure 28. Floodway sill groin, 8 September 1980.

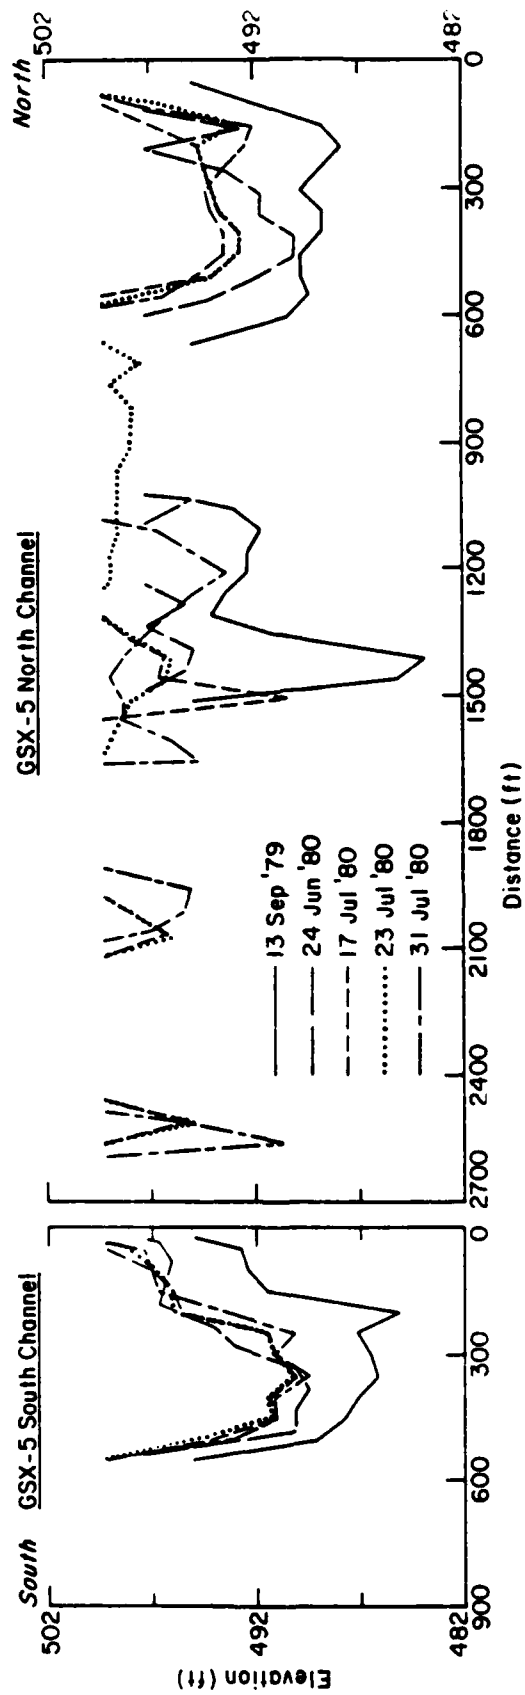
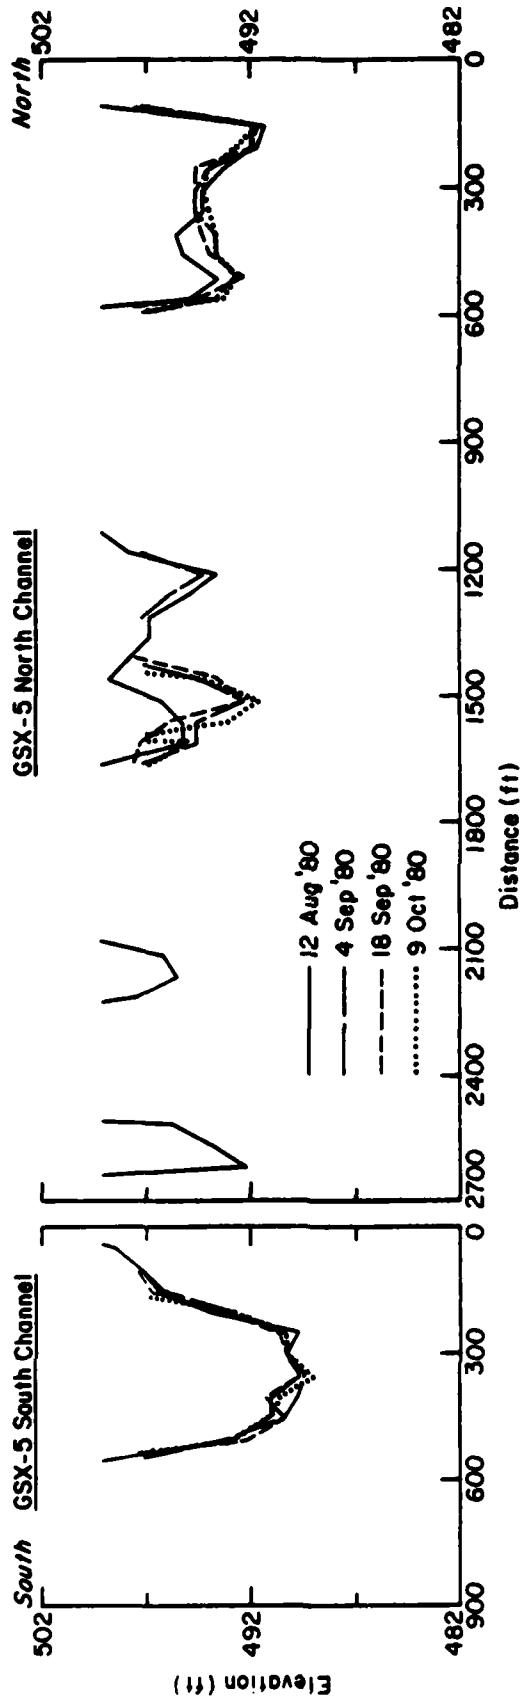
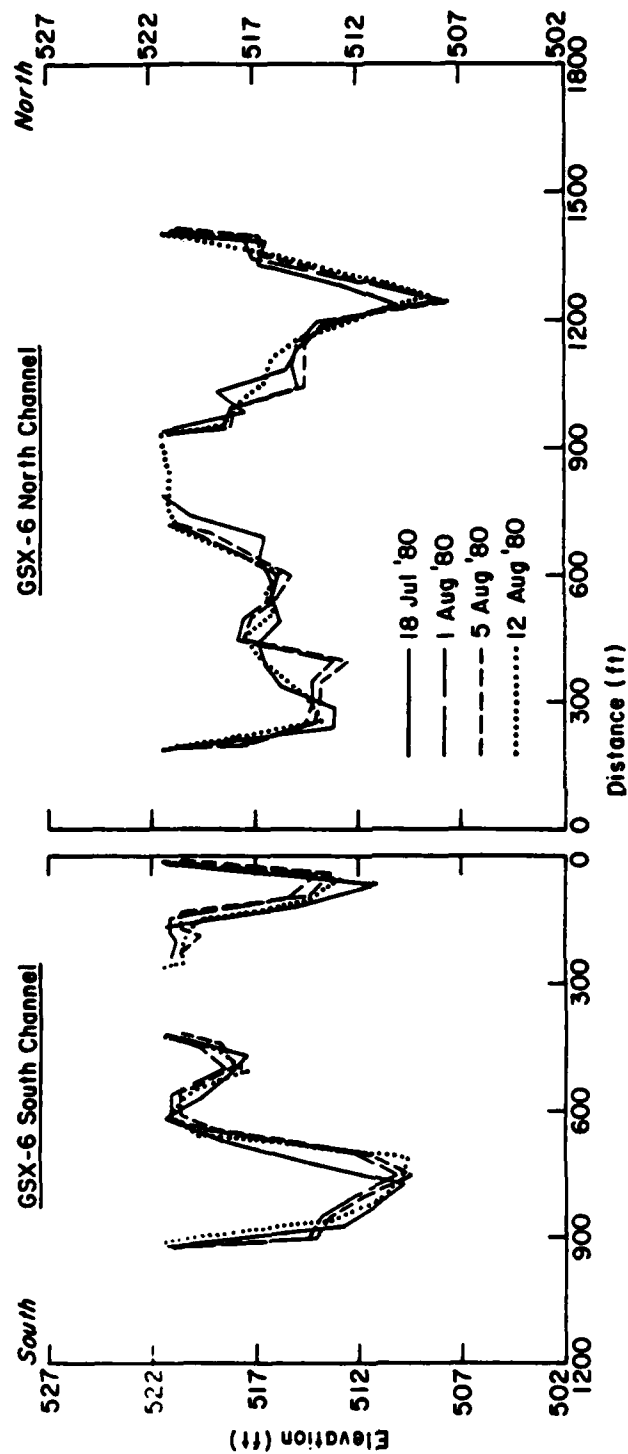
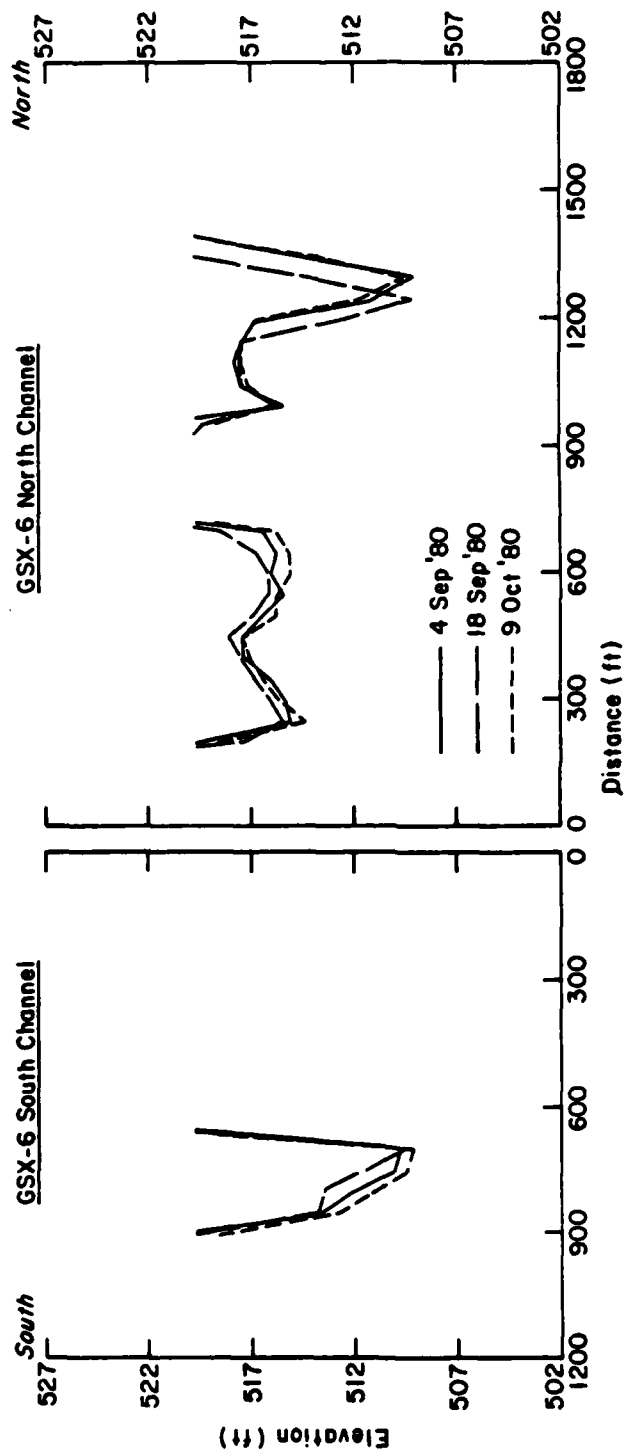
Figure 29. Cross-sections taken in 1979 and 1980 after construction of the floodway sill groin.

The cross-sectional changes that occurred from 1979 to 1980 are as follows (Fig. 29). The south and north channels at GSX-5 were deeper in September 1979 at the end of the high discharge 1979 season. By 24 June 1980 the channels were generally filled-in. During the 1980 season the changes in the south channels were minor while most of the change occurred in the north channel especially during the rising limb of the hydrograph from 24 June to 31 July 1980. Changes at GSX-6 were minor throughout the 1980 season.

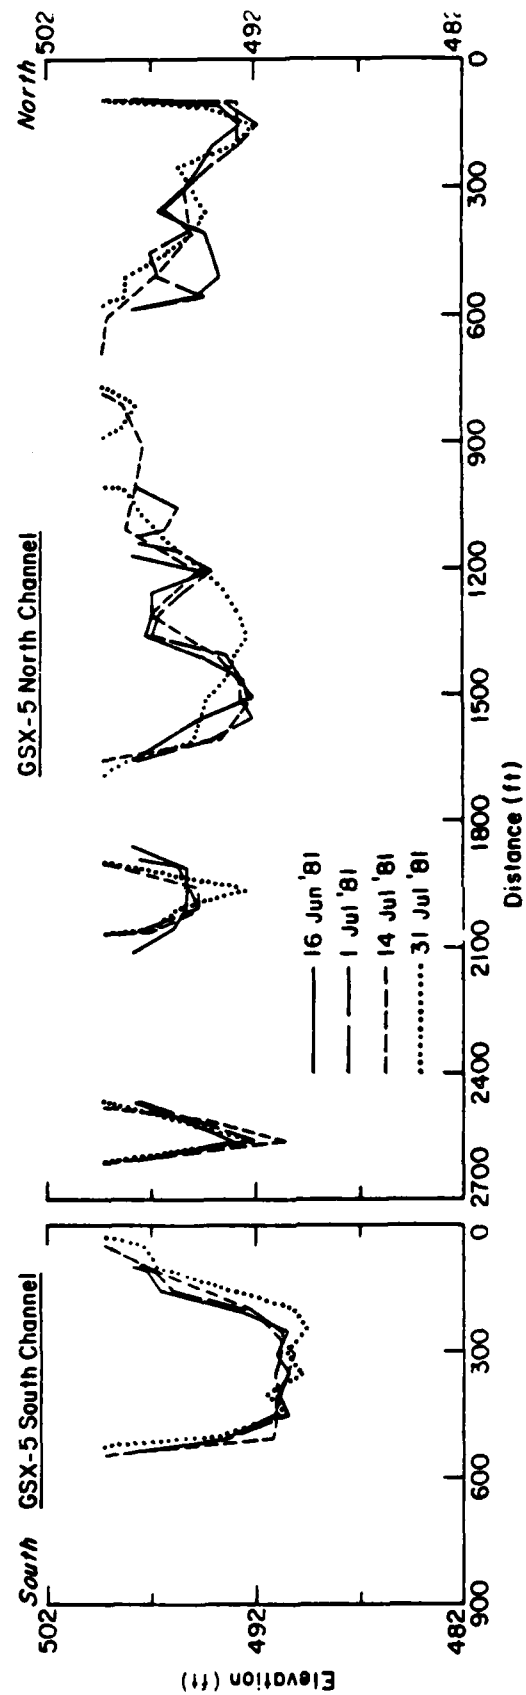
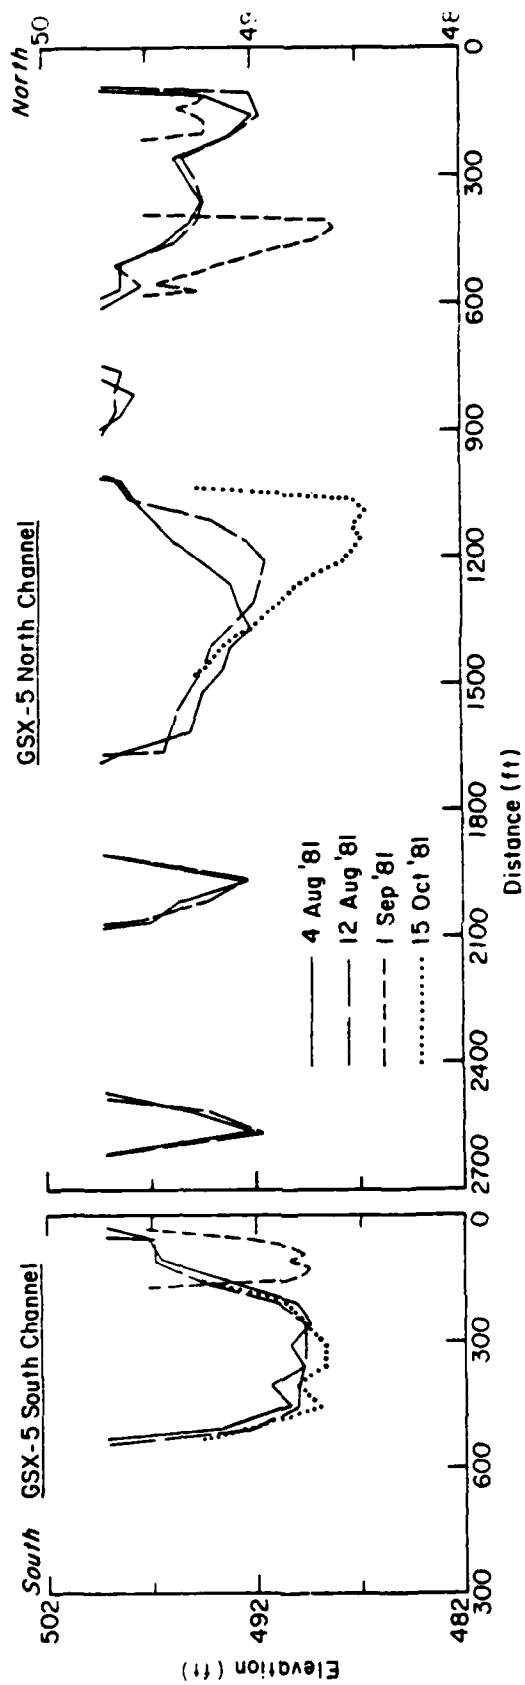
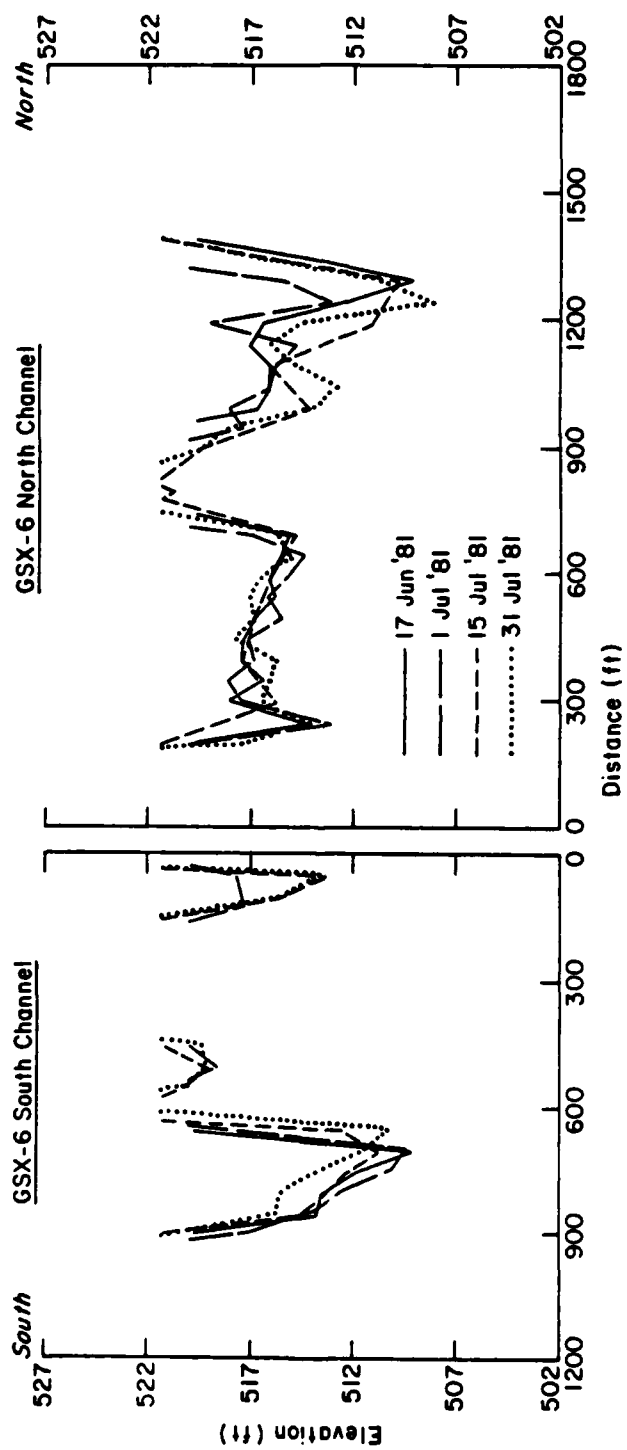
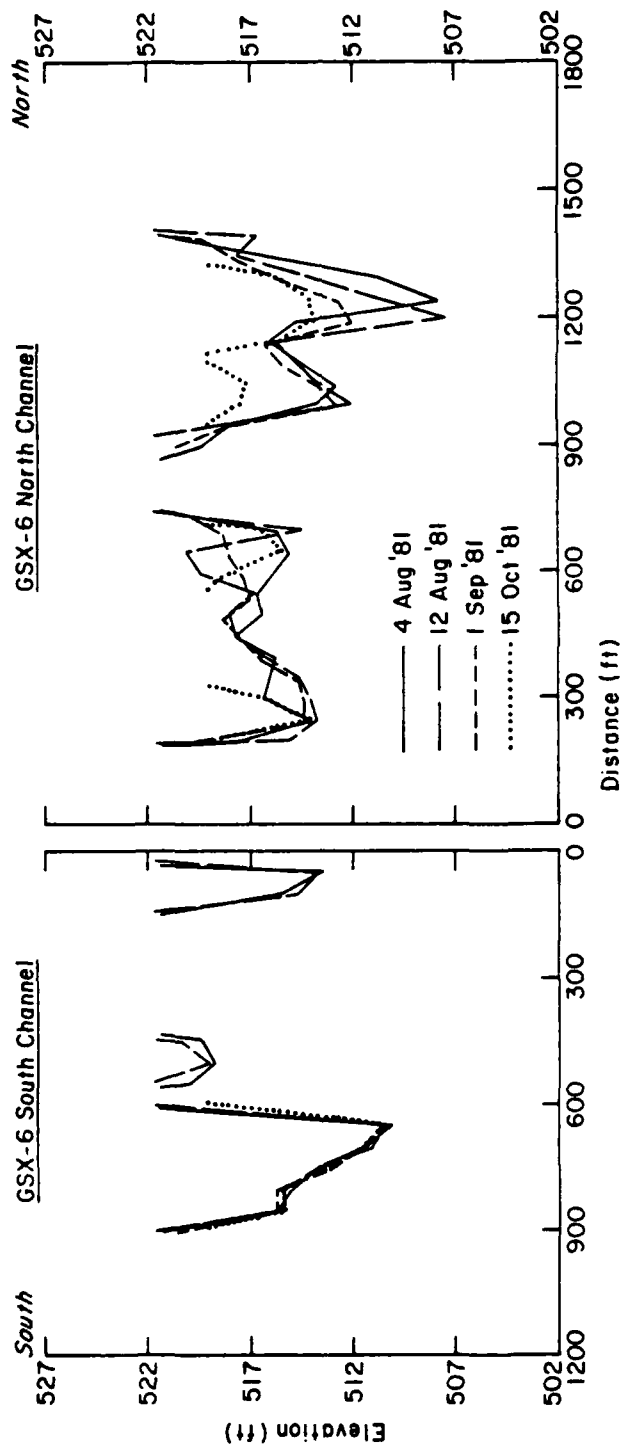
Figure 30. Cross-sections taken in 1981.

The cross-sectional changes that occurred in 1981 are as follows (Fig. 30). The south channel at GSX-5 showed little net change from 16 June 1981 to 15 October 1981. The northern part of the north channel changed considerably during the runoff season. In the middle portion it deepened about six feet and shifted to the north about 300 ft between
